**Conservation Area Appraisal and  
Management Plan  
2012**

# **TEVERSAL**

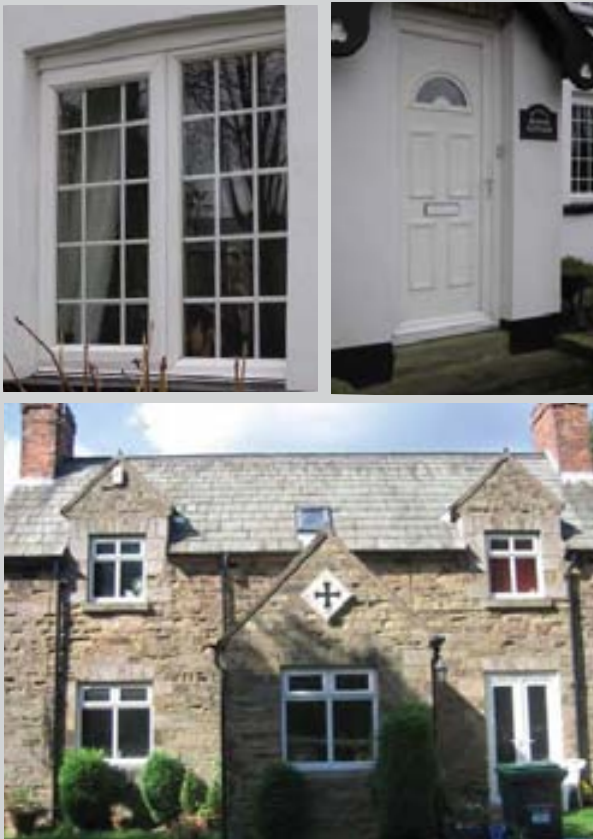
UPVC windows and doors in character properties. This should be discouraged in preference to traditional wooden framed windows and doors.

- 13.2.1 **Replacement Modern Materials:** The main threat to the character and appearance of the Conservation Area are the use of modern replacement windows and doors on both listed and unlisted historic buildings. These materials are becoming more prevalent and erode the character and appearance of the Conservation Area, particularly when they are inserted in one building where the others still retain their original windows and doors. A number of modern style timber doors and windows,

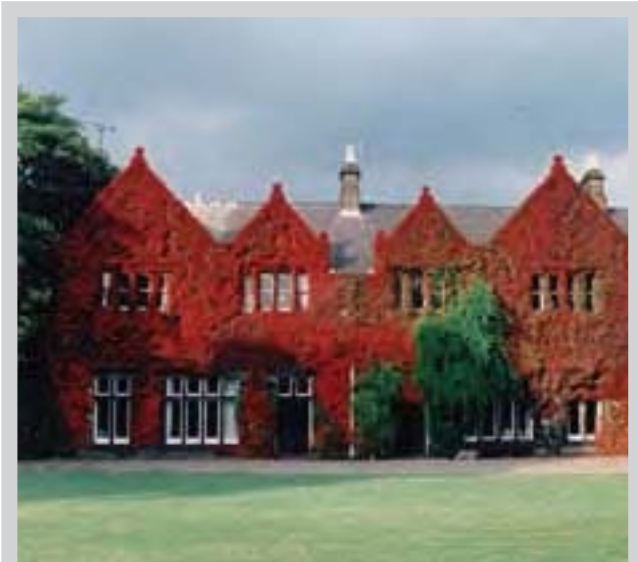
Holly and ivy have created a thick coverage on a number of walls in Teversal, including most of the south face of the Manor.

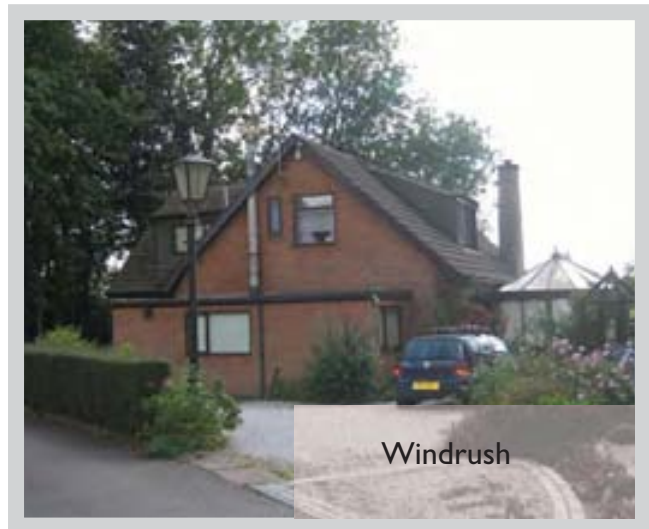
Windrush

11.2.2 Adjacent to Hill House is a slightly larger residential property which dates from the 1970's. **Windrush** consists of a single storey building with a second floor constructed under eaves. Its distinctiveness results from its tall chimney stack and flat-roofed ground floor extension although it is regarded as contributing little to the Conservation Area's character.

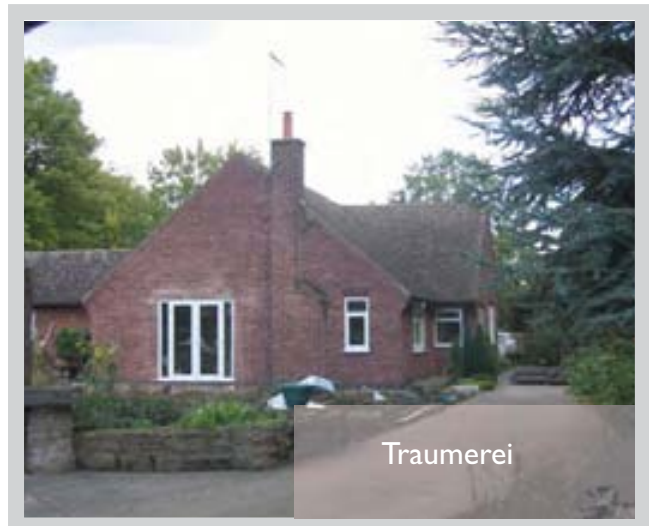
11.2.3 **Traumerei** is a single storey red brick bungalow which is located on the opposite side of Manor Close from Windrush. This dwelling was constructed in the last half century and possesses a grey slate roof, UPVC windows and a recent UPVC conservatory extension. Although not of a style that contributes to the character of the Conservation Area, Traumerei is set back, within a large and well kept garden that enhances the natural beauty of this section of the village.

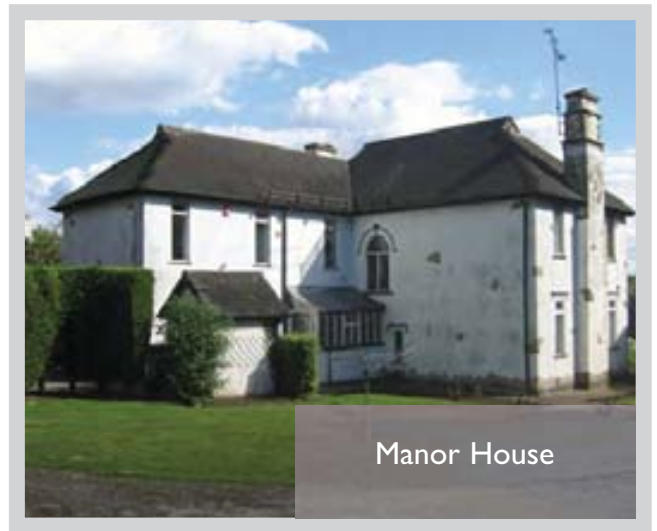
Manor House

11.2.6 The property adjacent to The Spinney possesses a large front garden and is setback from the road. **Manor House** is a large L shaped property dating from the 1950s, rendered with distinctive black drainpipes. The render has been applied in an unusual fashion and has been weathered by nearby trees. It has faded somewhat but the slate roof has been well preserved along with the exceptionally tall chimney stack. The tall, metal-framed rectangular windows with light blue casements are somewhat out of character

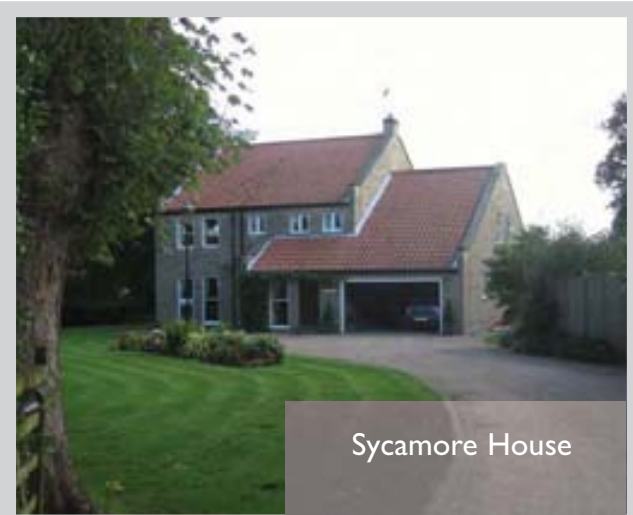
11.3.35 A short distance from Sycamore House the road divides. A turn to the right leads down a narrow road lined with Lime and Oak trees with an historic wall on the right hand side. This wall possesses examples of ribbon pointing which should be discouraged on historic walls/ buildings due to the damage which can be caused. The road here at one time may have only been a simple farm track and still possesses a comparatively informal layout with soft verges and glimpses of the villages agricultural past. The grass verges are important, not only from an aesthetic point of view, but also because they provide natural protection for the historic wall. All efforts should therefore be made
